# FRETTING WEAR ANOMALY OF FINAL CUBESAT EJECTION TESTS: EXPERTISE, SOLUTION TESTING, AND LESSONS LEARNT

During the qualification campaign of the satellite (PFM), vibration testing of the ANGELS cubesat in its deployer was performed at PFM levels. A deployment test was then carried on and showed that the satellite was stuck inside the deployer. Investigations quickly focused on a tribological issue because wear marks and particles were found after extraction of the cubesat. Equivalent friction coefficient calculations from sat/deployer ejection tests led to  $\mu > 0.9$  which suggested sticking or gripping phenomena.

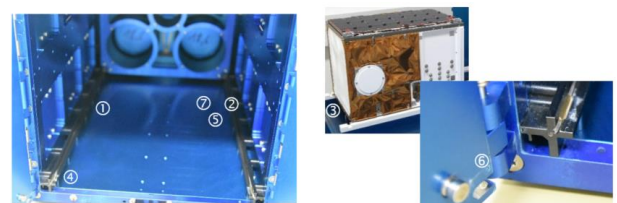
Figure 2: Sampling areas

During visual inspections, we noticed that at least 3 areas were subjected to abnormal wear and a lot of particles were present. Two of these areas are located near

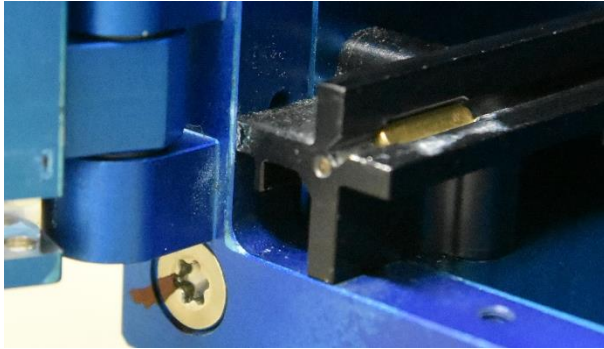
switches of the deployer rails. The corresponding areas on the satellites rails exhibits also a lot of wear.

Figure 3: Wear and particles near a switch

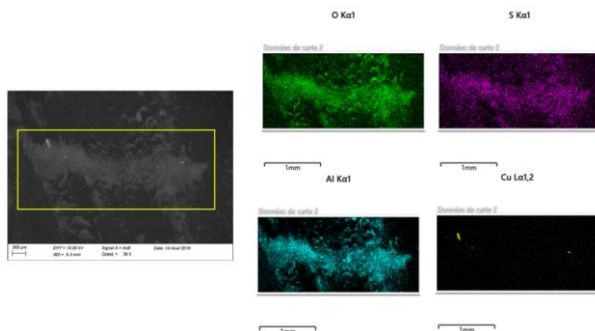
Particles were sampled using carbon adhesive on SEM stubs and were analysed using SEM and EDX. The results showed that the particles were mainly composed of alumina. Traces of Zirconium, Titanium and fluor were also found. On satellite side the rails are made of Al7075 treated by hard anodic oxidation and surtec 650. On the deployer side the rails are made of Al7021 treated by Hard anodic oxidation and interflon. The composition of the particles is thus consistent with the materials in contact.

Figure 4: Example of an EDX analysis

At this stage, the hypothesis of an external contamination acting like a third body in the contact and increasing the wear was excluded. All the particles came from the contact itself and the third body is not an external contamination but the product of the wear itself.

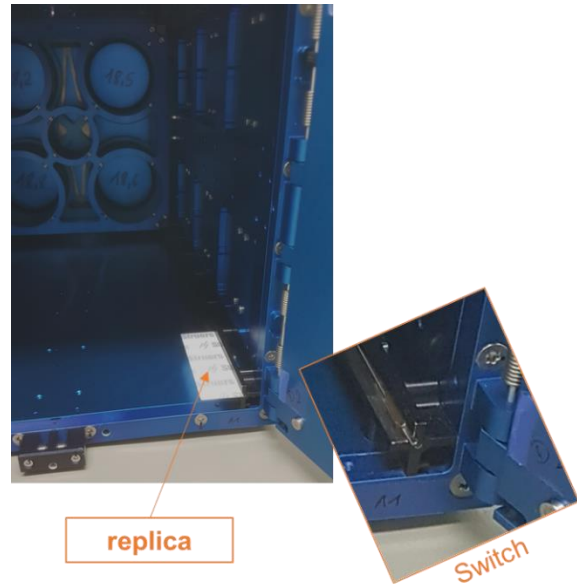
Figure 5: Example of a silicone replica on the deployer rail

The wear area on the Figure 5 shows almost no wear. The mean surface in the area is 800nm above the original mean surface. We also notice that the surface in the wear area is smoother than the original surface.

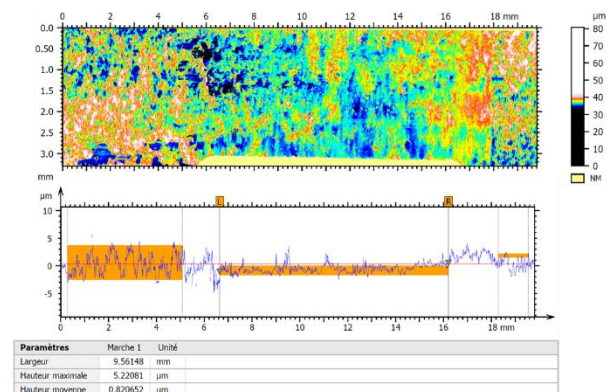
Figure 6: Profilometry on the deployer rail

With a closer look on this surface we were able to see that the worned surface could be locally 5 to 6μm above the original surface.

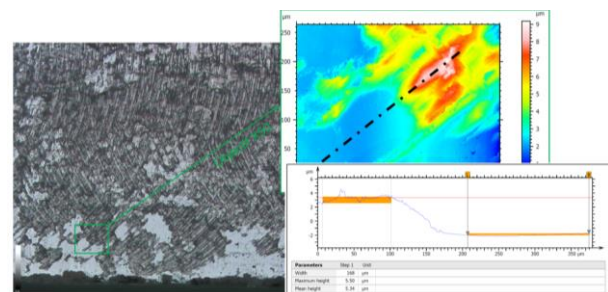
Figure 7: Material trapped in the roughness of the deployer rails

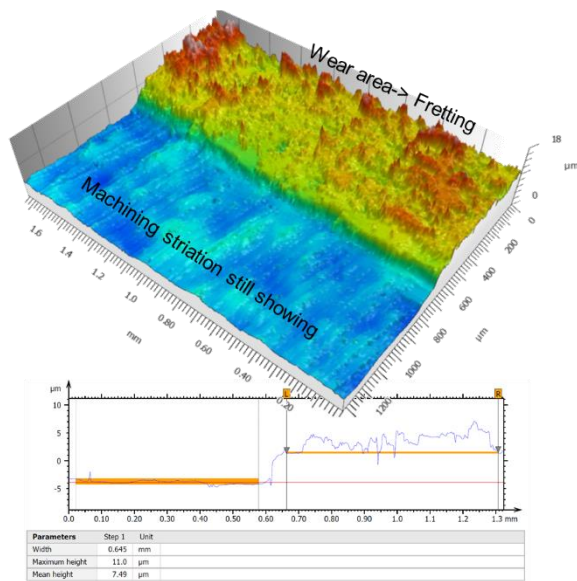
Figure 8: Profilometry on a wear zone of the satellite rail

The same analysis performed on the satellite rails exhibited more than  $7\mu\text{m}$  of wear in average. Wear areas are well defined and it is not hard at all to define a frontier between the wear and the original surface. Moreover the bearing surface at  $7\mu\text{m}$  of the satellite tracks if 100%. Meaning that the bearing surface can no longer increase with wear (locally at least) and that the wear phenomenon is not behaving like a run-in but will continue without any counter-measures.

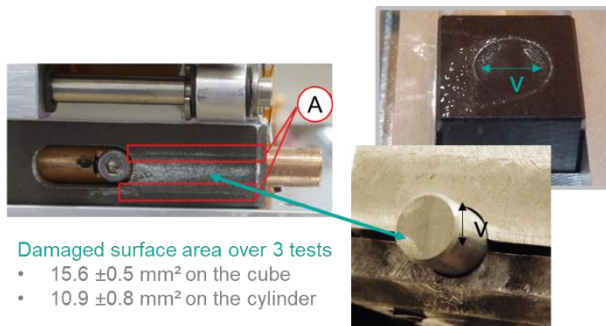
samples, after tests in dry conditions. Features, morphology (surfaces and debris) are successfully reproduced. Contact effectively occurs over few large spots. Over the 3 unlubricated test samples, the damaged area remains quite constant and varies little from one test to another.

Figure 9 - Comparison of damaged areas from satellite and from tribometer tests samples. The arrow v displays the sliding direction during the friction tests

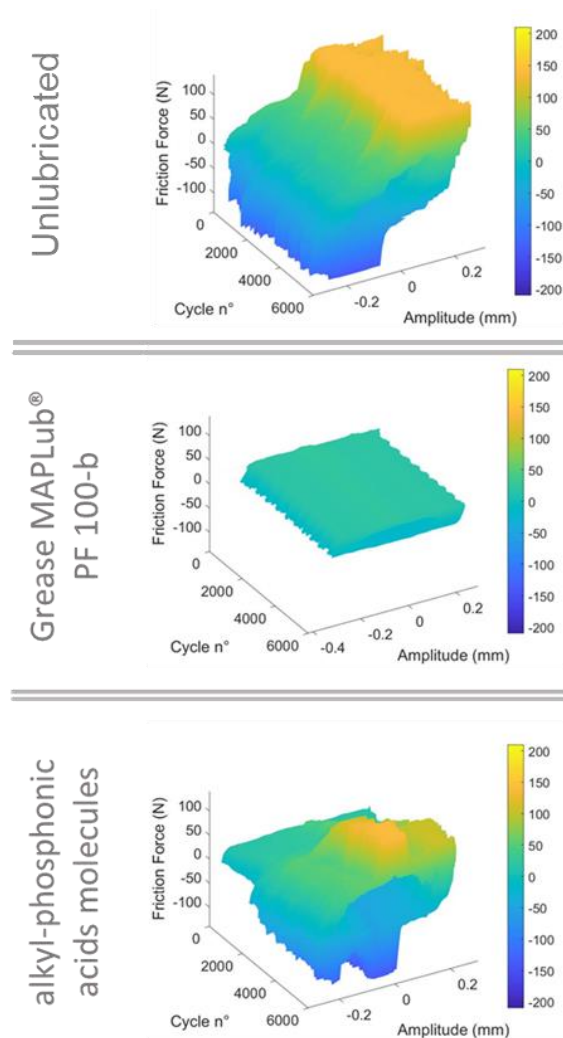
Figure 10 - Fretting loops of the fretting unlubricated and lubricated tests. The loop shape, with curvy sides, is typical of high adhesion fretting in sinusoidal displacement

Figure 10 is showing the fretting loop obtained during the fretting test in unlubricated condition, and in lubricated conditions after lubricant is applied on the damaged surfaces. It can be seen that in the unlubricated case, the friction demonstrates partial slip and very high amplitude of friction force, up to 100N in average (0.7 friction coefficient), pic at 140N (1 friction coefficient). During the test, particles are rapidly created and ejected continuously outside the contact, as evidenced on the cubic sample in Figure 9. White debris are indeed observed in the left side of the contact area. White 3<sup>rd</sup> body patches, are observed inside the friction tracks, in the mostly loaded areas. amount may have not been sufficient to sustain lubrication over the full test.

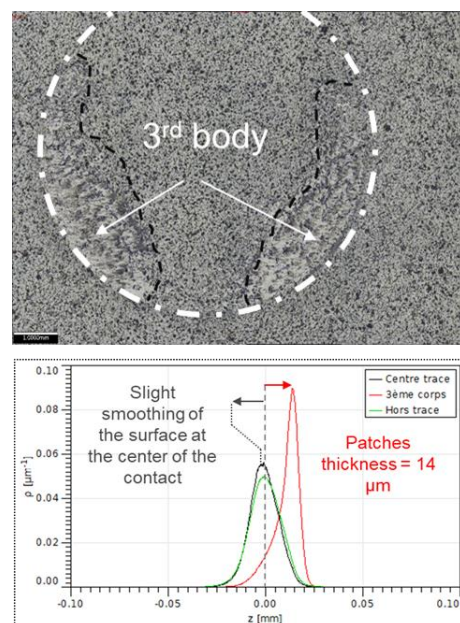
The optical analysis of the unlubricated samples shows that the worn samples is mainly the samples emulating the satellite. It also and that the 3<sup>rd</sup> body accumulate to form thick 3<sup>rd</sup> body patches. Figure 11 indeed shows that the cubic sample is not demonstrating significant wear, the surface at the centre of the contact is slightly smoother than the pristine surface. At the mostly loaded areas, 3<sup>rd</sup> body accumulates to create patches reaching a thickness of 14  $\mu\text{m}$  above the overall sample surface. The cylinder surface (not shown) demonstrate mostly few microns deep worn region. Areas with accumulated 3<sup>rd</sup> body demonstrate 3<sup>rd</sup> body whose thickness may locally reach 2  $\mu\text{m}$ . EDS analysis shows that debris and 3<sup>rd</sup> body are only coming from the cylinder (satellite-based material)[1]. Note that no fluorine is detected on the cubic samples (layer too thin?) but it on the cylinder material. Surtec650 is indeed containing fluorine [4]. The oxygen content is however significantly higher than what it is detected on the pristine materials, which is typical of tribo-oxidation seen during fretting tests in air [2,5].

Figure 11 - Optical topography image and height distribution of the 3<sup>rd</sup> body.

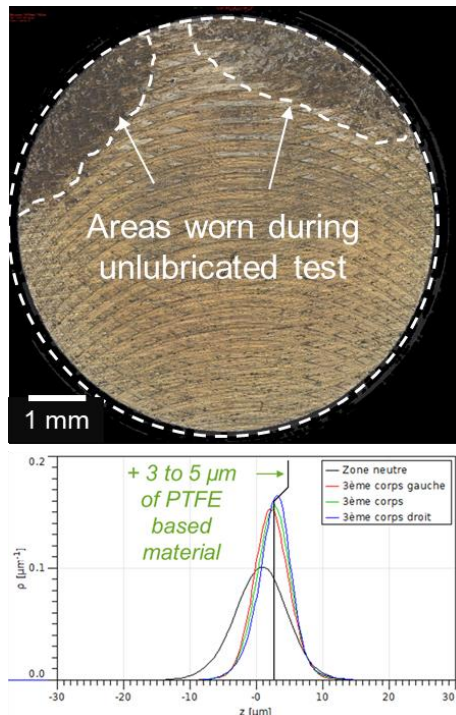
Figure 12 - Optical topography image of the cylinder sample demonstrating large accumulation of PTFE based lubricious material in previously worn areas

The grease lubricated test sequence demonstrates very stable pure sliding friction with a friction force of 15N in average (0.1 friction coefficient). The optical topography shows accumulation of 3<sup>rd</sup> body from coming from the grease and remaining rigidly bounded to the initially worn areas of the surfaces. This demonstrated on the mostly worn samples, the cylinder (Figure 12). Such PTFE layer formation behaviour has been shown to happen with grease containing PTFE particles [6]. While PTFE appears to bind only on the initially worn areas on the cylinder (i.e. on the satellite material), it is found everywhere in the contact on the cubic samples (i.e. deployer material), with slightly thickest patches in initially worn areas.

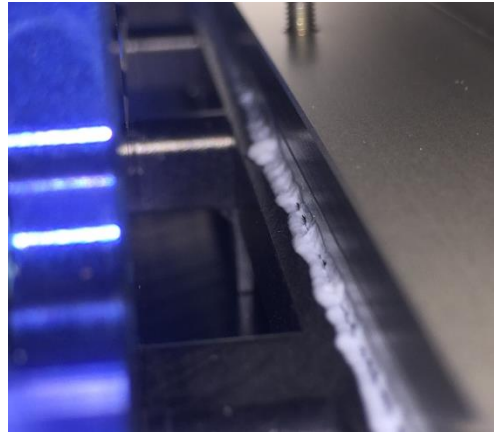
Both satellite dummy and deployer QM were submitted to a full mechanical vibrations qualification sequence (@qual level for 2 minutes, cf. Figure 15). Grease behaviour was observed during vibrations on bottom rails through an opening in the deployer. A grease bulge was observed and confirmed a satisfying grease circulation in the contact (cf. Figure 16).

Figure 16 Grease bulge showing grease circulation on bottom rails

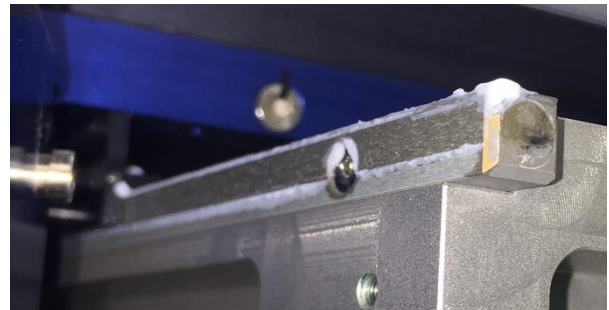
were observed on both the satellite dummy and the deployer rails (cf. Figure 18). Grease was indeed observed on all sliding surfaces as expected. This successful test confirmed the choice of the corrective actions to solve ejection anomaly.

Figure 18 Satellite dummy rail after ejection test : no fretting marks were observed
