# **Thermal and hydrothermal ageing of flax/polypropylene composites and their stainless steel hybrid laminates**

## **Abstract:**

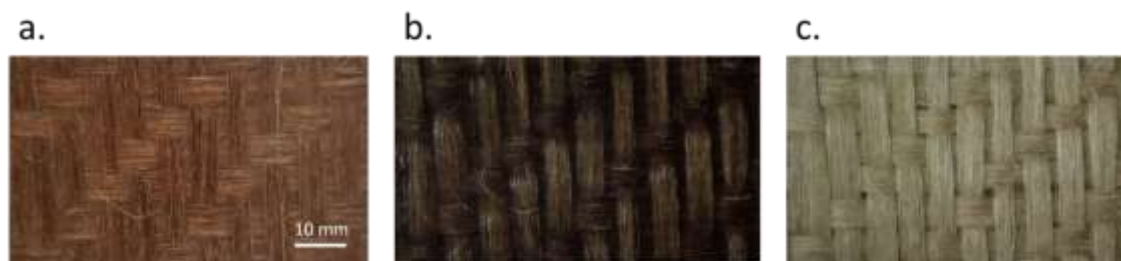
Figure 3: Evolution of the appearance of the composite specimens during hydrothermal ageing. a.) Before immersion, b.) immediately after removal from water after 50 days of hydrothermal ageing and c.) after hydrothermal ageing and drying.

faces and capillary mechanisms originating from the unprotected edges. A progressive and quasi-linear mass loss was then observed from 40 to 180 days of ageing. This mass loss was attributed to the degradation and leaching of the flax fibres. Immersion in hot water is well known to induce the extraction and hydrolysis of pectins and hemicelluloses from flax and then their release and dissolution in water [23]. These biochemical modifications could also explain the significant change in colour observed during hydrothermal ageing (Figure 3). It was observed a colour change from yellow–brown before flax was immersed to dark-grey when it was immersed and water-saturated. Similar colour transitions were previously observed for flax and hemp fibres during dew retting [24, 25]. This darkening in the fibres was attributed to the metabolic activities of microorganisms during retting [26]. After hydrothermal ageing and drying, the fibres returned to a clear and whitish colour (Figure 3c).

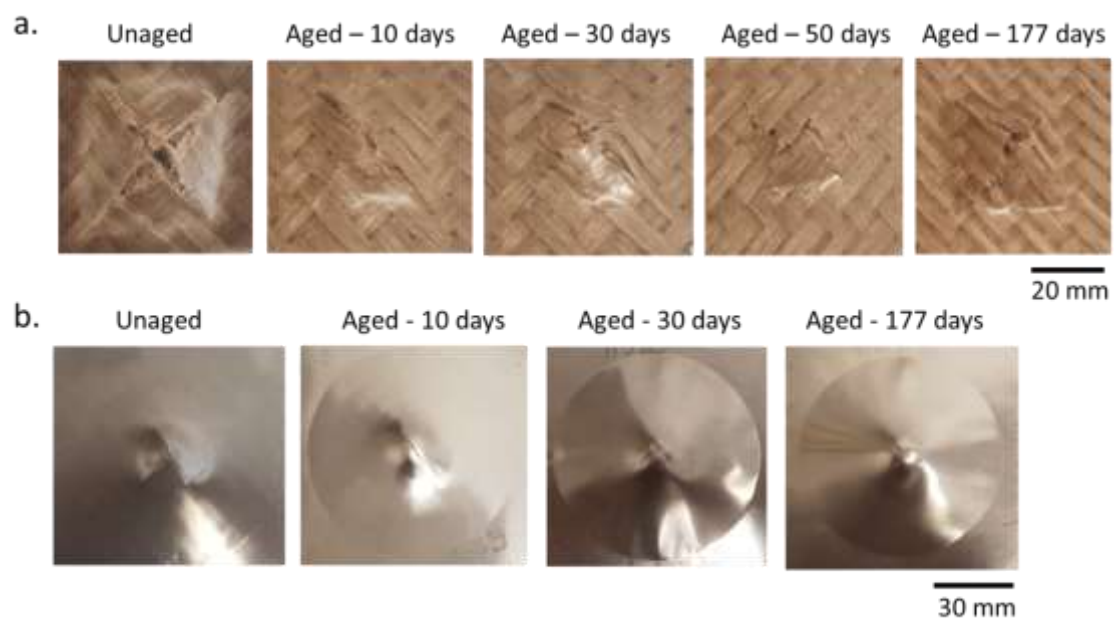
Figure 10: Back surfaces of impacted specimens after different hydrothermal ageing times. (a) composite specimens and (b) hybrid specimens.

The impact behaviour was also significantly affected by hydrothermal ageing for both composites and hybrids. In the case of composite specimens (Figure 9a), the initial slope of the load displacement curve decreased after 10 days of ageing and remained stable thereafter. This was consistent with the modulus drop observed in bending specimens. The maximum load slightly increased in the first period of ageing and strongly reduced after 177 days (Table 2). Observations of the impacted specimens showed that the perforation induced marked orthogonal cracks along the fibre directions in unaged specimens (Figure 10a). For specimens aged 10, 30 and 50 days, the damage was more diffuse in the affected area. At 177 days, the cracks were again very marked,

but the affected area was strongly reduced in size compared to the unaged specimens. This behaviour could have been related to evolution of the plasticity of the material, which would have been consistent with the evolution of the failure strain observed in bending. In the case of hybrid specimens, a decrease in initial stiffness was also observed with ageing but only after 30 days (Figure 7b and Table 2). It was possible that after 10 days of ageing, the composite material in the centre of the specimen was not yet saturated with water because the weight gain was not stabilized for impact specimens after 10 days (Figure 2). As observed in bending specimens, there was no real performance loss between 30 and 177 days, and the absorbed energy even increased. The observations of the impacted specimens (Figure 10b) made it possible to formulate some explanations for this behaviour. For unaged specimens, the area deformed by impact was small, and cracks were present in the skin at the back. With ageing, this area increased significantly due to the more widely distributed plastic deformation in the skins, which were less constrained by the composite core. It is interesting to note that the skins were not cracked during impact after 30 days.

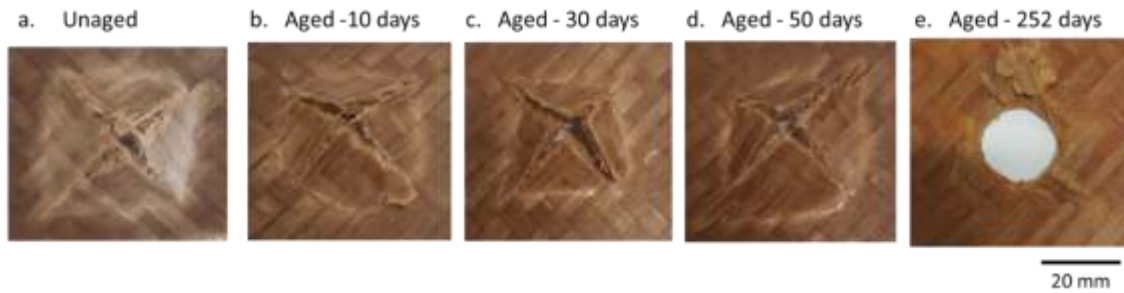
Figure 17: Back surfaces of the composite specimens after impact tests after different thermal ageing times.

The impact resistance of the composite was also strongly affected by thermal ageing (Figure 16b and Table 3). The maximum force, energy absorbed and displacement at perforation decreased slightly and progressively for ageing times up to 50 days. This was mainly attributed to the drying of the material. For the bending properties, a significant drop in impact properties was observed after 252 days. The failure mode (Figure 17) was completely different with complete perforation of the plate, without

tearing around the hole. This could again be attributed to the embrittlement of the PP matrix induced by thermal oxidation.
