# FRETTING WEAR ANOMALY OF FINAL CUBESAT EJECTION TESTS: EXPERTISE, SOLUTION TESTING, AND LESSONS LEARNT

During the qualification campaign of the satellite (PFM), vibration testing of the ANGELS cubesat in its deployer was performed at PFM levels. A deployment test was then carried on and showed that the satellite was stuck inside the deployer. Investigations quickly focused on a tribological issue because wear marks and particles were found after extraction of the cubesat. Equivalent friction coefficient calculations from sat/deployer ejection tests led to  $\mu > 0.9$  which suggested sticking or gripping phenomena.

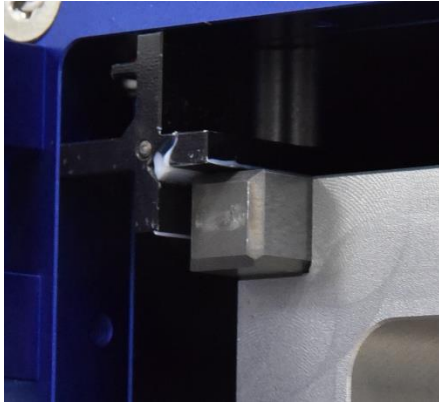
Figure 14 detail view of a rail after satellite dummy installation in deployer (QM)

Satellite dummy was then inserted into the deployer with a particular care on Sat/deployer alignment in order to avoid removing greases from the lubricated surfaces (cf. Figure 14).

Both satellite dummy and deployer rails were cleaned meticulously with isopropyl alcohol. MAPLub PF100b grease was applied on deployer side as shown in Figure 13 with a particular attention on the amount of grease: groove of the rail was filled of grease and a dedicated tool was used to spread the rest of the grease (0.2mm film thickness) while removing lubricant excess (cf. Figure 13 C).

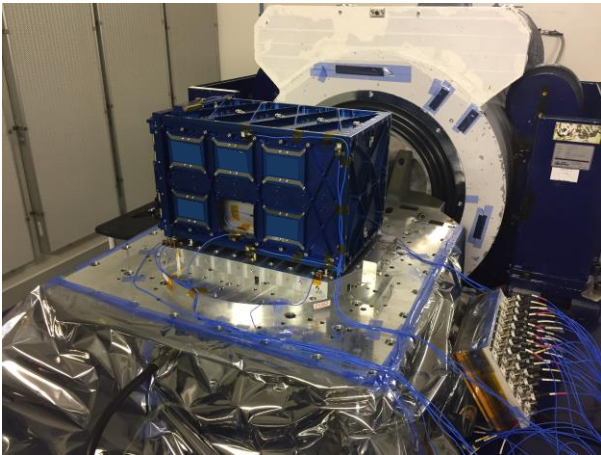
Figure 15 Deployer QM with satellite dummy on MID shaker

Both satellite dummy and deployer QM were submitted to a full mechanical vibrations qualification sequence (@qual level for 2 minutes, cf. Figure 15). Grease behaviour was observed during vibrations on bottom rails through an opening in the deployer. A grease bulge was observed and confirmed a satisfying grease circulation in the contact (cf. Figure 16).

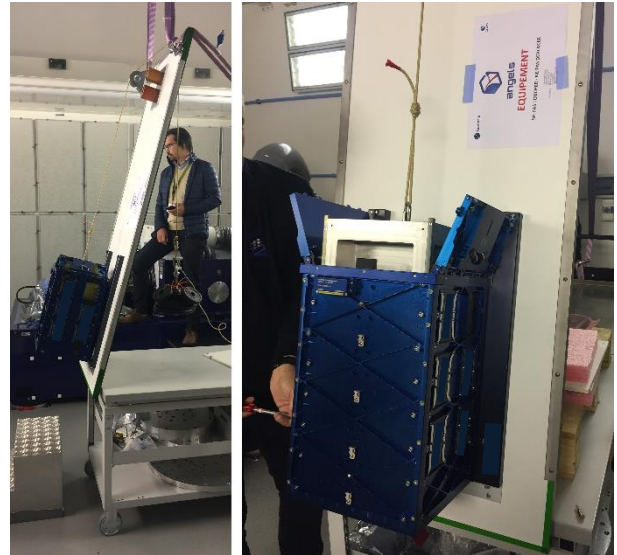
Figure 17 ejection test configuration

An ejection test was then performed at 75° (cf. Figure 17) in order to limit gravity effect on friction (with 1g compensation). A particular care has been paid in transporting the deployer on the ejection test GSE to avoid “unsticking” the satellite from the rails. Satellite dummy was successfully ejected from the deployer with satisfying margin. In addition, no wear or fretting marks
