Extreme wave events in Ireland: 2012 - 2016

Abstract. This paper aims to extend and update the survey of extreme wave events in Ireland that was previously carried out by O'Brien et al. (2013). The original catalogue highlighted the frequency of such events dating back as far as the turn of the last ice age through to 2012. Ireland's marine territory extends far beyond its coastline and is one of the largest seabed territories in Europe. It is therefore not surprising that extreme waves have continued to occur regularly since 2012, particularly considering the severity of weather during the winters of 2013-14 and 2015-16. In addition, a large number of storm surges have been identified since the publication of the original catalogue. This paper updates the O'Brien et al. (2013) catalogue to include events up to the end of 2016. Storm surges are included as a new category and events are categorised into long waves (tsunamis and storm surges) and short waves (storm and rogue waves). New results prior to 2012 are also included and some of the events previously documented are reclassified. Important questions regarding public safety, services and the influence of climate change are al

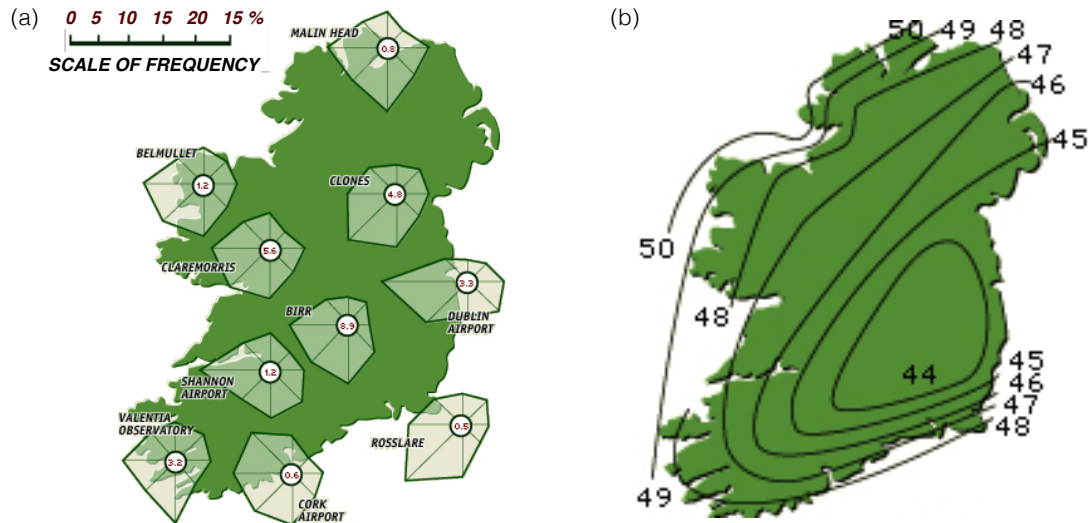
Figure 1. (a) Percentage Frequency of wind direction with circled number representing the percentage of calm days. (b) Maximum gust speed likely to be exceeded once in 50 years (m/s). (Met Éireann, 2016c)

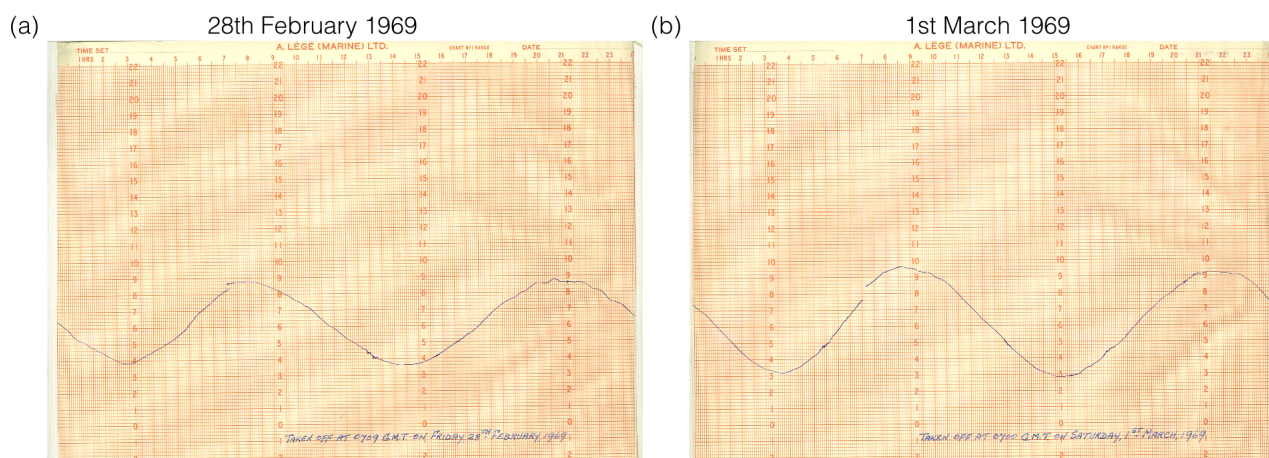
Figure 2. Tide gauge recordings at Belfast harbour on (a) 28th February 1969 and (b) 1st March 1969. Minor oscillations can be seen upon close inspection. Retrieved through personal contact with the the Permanent Service for Mean Sea Level (2016), (Holgate et al., 2013).

25 In addition to the 1755, 1761, 1941 and 1975 Lisbon, tsunamis documented in O’Brien et al. (2013), there was another significant earthquake and tsunami near Lisbon on the 28 February 1969. The tide gauge recordings at Belfast harbour show small oscillations which may be the arrival of this tsunami, see Figures 2. In addition, another tide gauge recording has been located for the 1975 tsunami. The recording is taken at Belfast harbour and is shown in Figure 3.

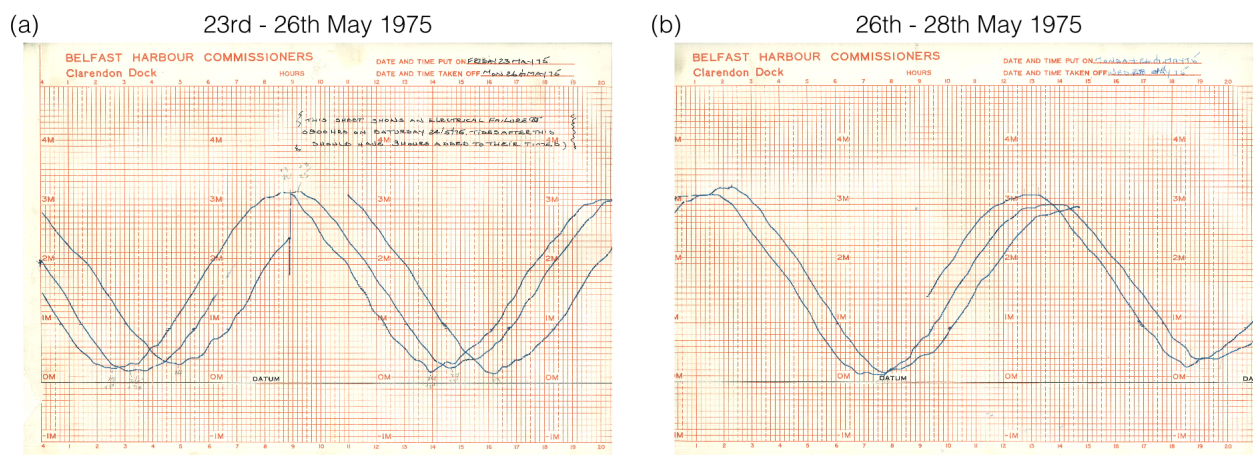
Figure 3. Tide gauge recordings at Belfast harbour on (a) 23rd - 26th May 1975 and (b) 26th - 28th May 1975. Minor oscillations can be seen upon close inspection. Retrieved through personal contact with the Permanent Service for Mean Sea Level (2016), (Holgate et al., 2013).

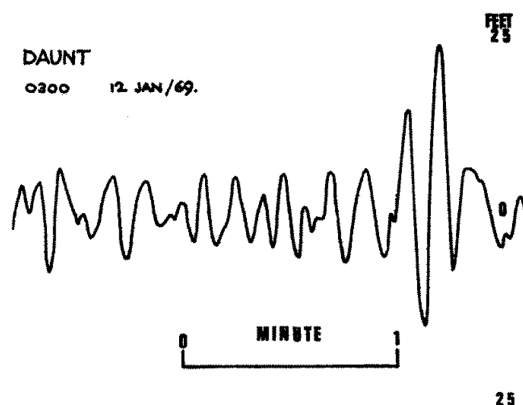
Figure 6. Wave recorder trace taken on 12th January 1969 (Figure 1 in Draper (1971))

Draper (1971) shows a record from the 12th January 1969 taken by the Commissioners of Irish Lights with a shipborne wave recorder on *Daunt* light-vessel off Cork showing a wave that is 4.1 times the average wave height. Given that the average wave height would usually be around 0.63 times the significant wave height, this wave would be approximately 2.6 times the significant wave height. See Figure 6.

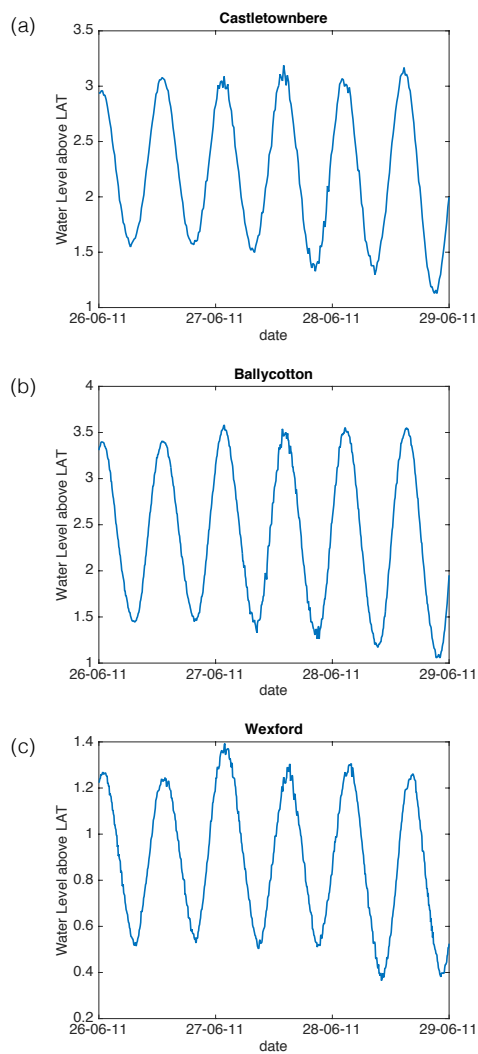
Figure 7. Tide gauge data from 26th-29th June 2011 at (a) Castletownbere (SW coast), (b) Ballycotton (S coast) and (c) Wexford (SE coast), small oscillations are clearly visible.

- The National Oceanic and Atmospheric Administration (2016) Tsunami database records a questionable tsunami on 27 June 2011 in Plymouth, England with run up values recorded at Newlyn, Plymouth, Portsmouth and St Michael’s Mount. The tide
20 gauge record at Castletownbere, Wexford and Ballycotton shows evidence of this wave in Figure 7. The tsunami cause is given as meteorological on the NOAA database, however, a BBC News report on 29/06/2011 suggests it was due to a sub-marine landslide.

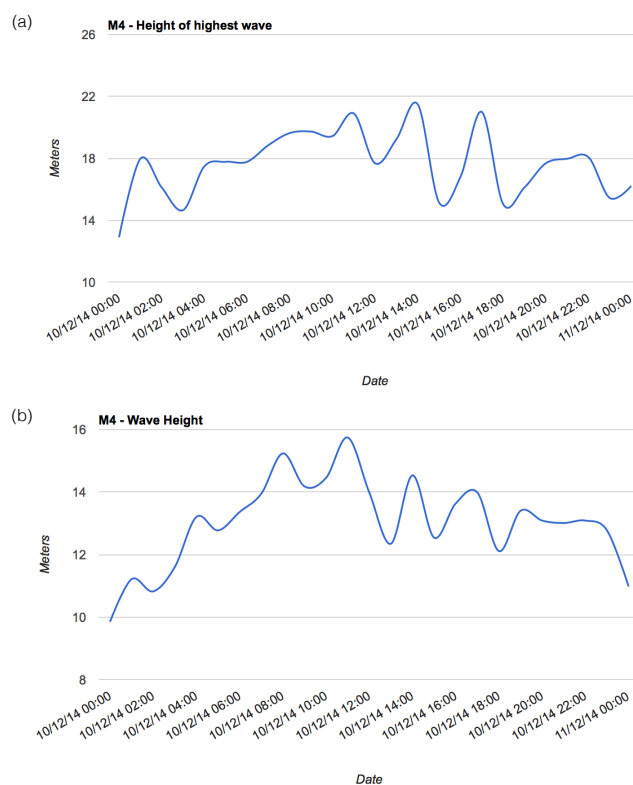
Figure 9. M4 records of (a) maximum wave height (m) and (b) significant wave height (m) on the 10th December 2014.

The M4 buoy located off the coast, Northeast of Belderrig, recorded a maximum wave height of 21.5 m on the same day, with a corresponding significant wave height of 14.5 m (see Figure 9). This is not classified as a rogue wave, however the waves hitting the coast of Co. Mayo on this day did significant damage. A local man pointed out that if the large waves had hit the coast at high tide, the damage could have been far worse. (*Personal contact with Seamus Caulfield and Gretta Byrne*)

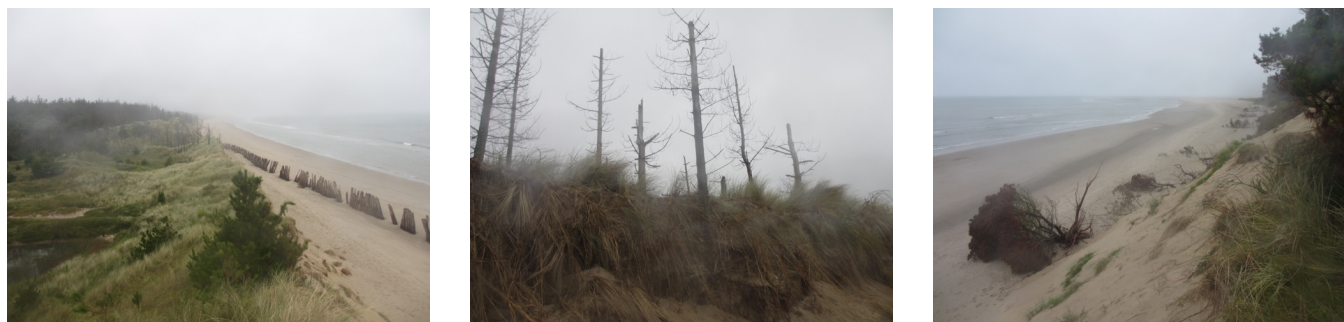
Figure 10. Pictures of the sand dunes at Culleton's Gap, Co. Wexford taken on 18 September 2016 approximately one month after the gales. (Source: *James Herterich*)

The sand dunes at Culleton's Gap (The Raven), near Curracloe, Co. Wexford were altered after gales on the 20th August 2016¹. Trees that line the beach were damaged, sand was shifted and tree roots were exposed (see Figure 10). Locals say that this

is a common phenomenon in the region, particularly with strong easterly winds. Presumably it is a combination of wind and waves that alters the dunes here.

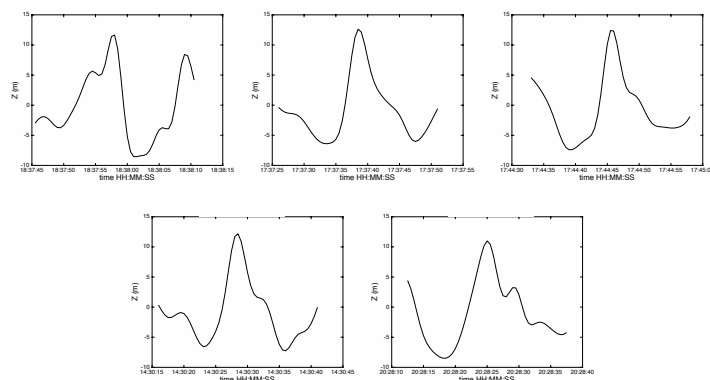
Figure 13. Large waves recorded by an ADCP near Killard, Co. Clare on the 22nd February 2015.

- 5 Flanagan et al. (2016) deployed a state-of-the-art Sentinel V Acoustic Doppler Current Profiler (ADCP) off the west coast of Ireland near Killard, Co. Clare from the 9th February to 1st May 2015. Their aim was to gather accurate wave measurements in extreme conditions. Of the 750,000 waves recorded and analysed, 13 were rogue waves (approximately 1 in every 60,000) and only 3 of these waves were greater than 4m and none exceeded 10m. A similar study of field measurements (Christou and Ewans, 2014) measured 3649 rogue waves in 122 million individual waves (approximately 1 in every 30,000).
- 10 A number of large waves with amplitudes close to 20m were recorded on the 22nd February, see Figure 13. This shows that large waves of interest are not always classified as rogue waves.

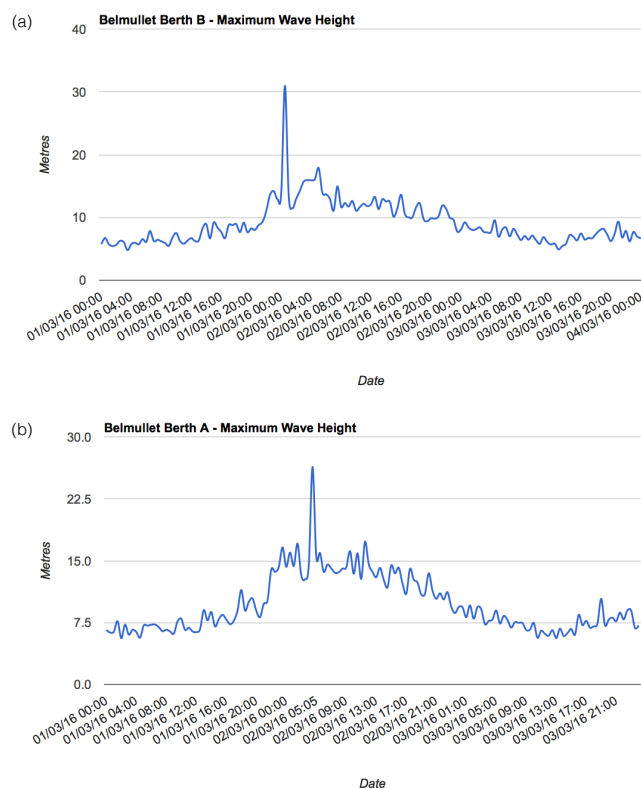
Figure 14. Maximum wave height at (a) Belmullet Berth B and (b) Belmullet Berth A wave buoys on 1st - 3rd March 2016.

15 Then in 2016, Storm Jake hit Ireland with severe winds of up to 133 km/hr on 2 March, and a 30.96 m wave was recorded at 00:30 on the wave buoy Belmullet Berth B (Figure 14). This could be interpreted as a suspicious reading given how big it is, however the nearby wave buoy Belmullet Berth A also recorded a 26.35 m wave at 03:30 (Figure 14) indicating that there were very large waves in the region. Since the buoy network was only set up in November 2000, it is not surprising that the record has been broken since 2011.

On the 7th August 2016, the Belmullet Berth A wave buoy recorded a rogue wave, in excess of 13 m (significant wave height of approximately 6 m). This was during a period of unusually windy conditions for the summer season.
